Eagle Home Inspections 2211 Durham Road Madison CT 06443 203-640-2053 ron@eagle-inspections.com

Confidential Inspection Report

Inspection Address

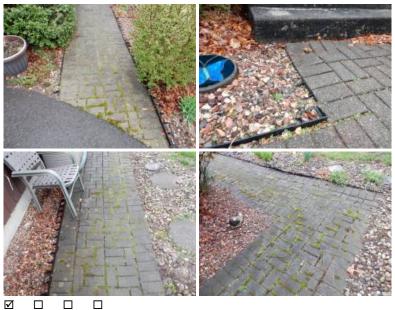
$\hfill\Box$ \hfill $\hfill\Box$ $\hfill\Box$ Sidewalk type: Paver/Tile, Surface raised/settled, Overgrown.

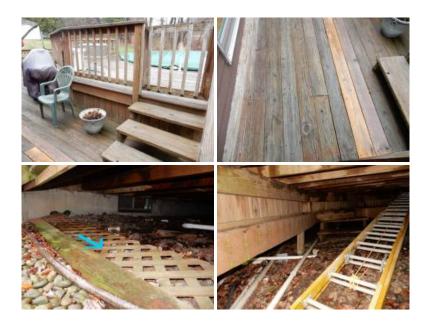
☑ □ □ Wood. No access below deck. Skirting around lower deck has fallen under deck.

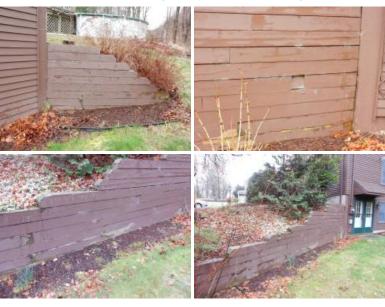
$\hfill\Box$ \hfill $\hfill\Box$ $\hfill\Box$ Retaining wall type: Wood. Peeling paint, deteriorated surfaces.

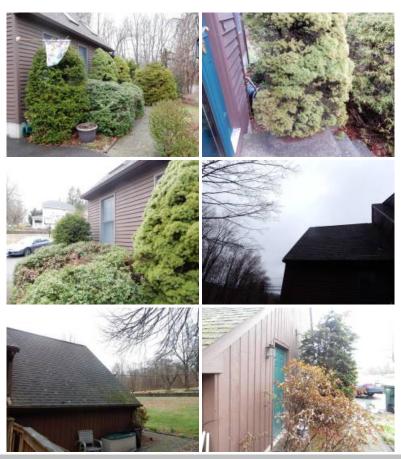
□ □ □ □ □ Foliage is overgrown and needs trimming. Trim plants away from structure leaving at least two feet of space. Trim all trees and limbs at least 10' away from structure. Trees planted close to structure. Removal/trimming may be needed. Trees/foliage touching the walls or overhanging the roof. Damage is possible.

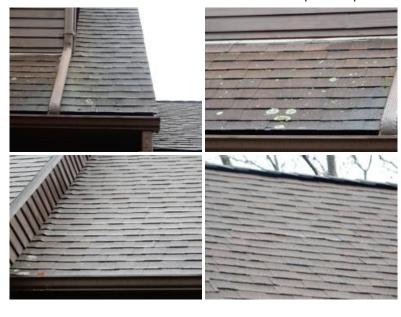
Composition shingles, Architectural heavy duty design. Moss/Lichen growth. Can be damaging to the surface. Decreases the roof life span. Clean debris from surface.

Moss and lichen growth. General condition appears serviceable with signs of normal aging. Regular maintenance and inspections are advised. A licensed roofing contractor should be called in to make further evaluation and to repair or replace as needed.
